MARCH 19, 1997

BUILDING PERFORMANCE ASSESSMENT:

# *Hurricane Fran in North Carolina*

OBSERVATIONS, RECOMMENDATIONS,  
AND TECHNICAL GUIDANCE

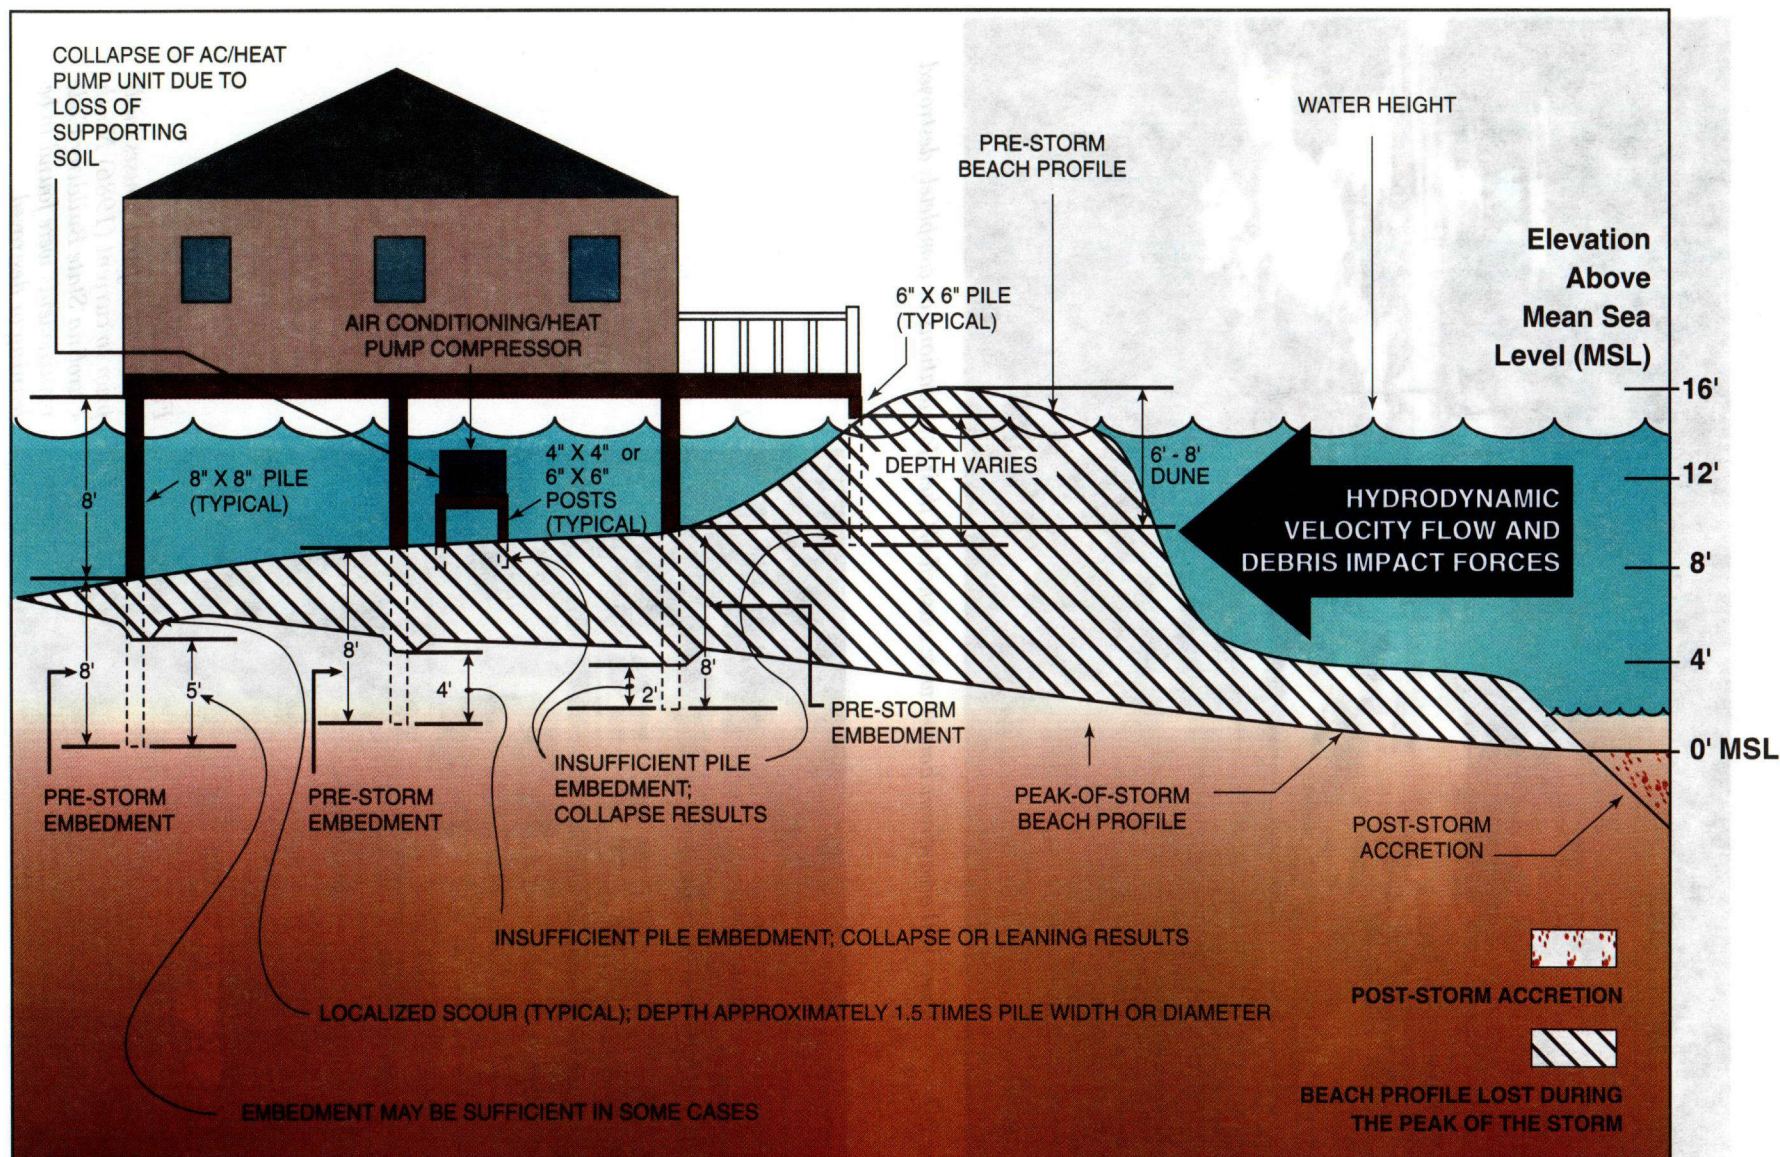
Lack of sufficient embedment of vertical structural foundation members may well have contributed to the collapse of over 100 oceanfront residential buildings (see Figure 2-7). Of those that did not collapse, many were found to be leaning (see Figure 2-8). The majority of these structures met the pre-1986 requirement for an 8-foot embedment of pilings and columns (measured from existing grade). Many front-row houses were placed near or on the landward slope of the frontal dune, where the ground elevations were often 8 to 9 feet m.s.l. As a result, the bottoms of the pilings or columns were at approximately 0 feet m.s.l. (see Figure 2-9)

Figure 2-9 Typical collapse mechanism of post-FIRM building based on pre-1985 embedment requirements in North Carolina coastal areas.

erosion were in areas where the ground elevations were low. For structures on higher dunes (i.e., where ground elevations exceed 11 feet m.s.l.) the piling embedment requirement changes to only 16 feet below grade. This embedment depth is not sufficient to allow the pilings to survive a similar storm or continuing long-term erosion of moderate to high dunes.

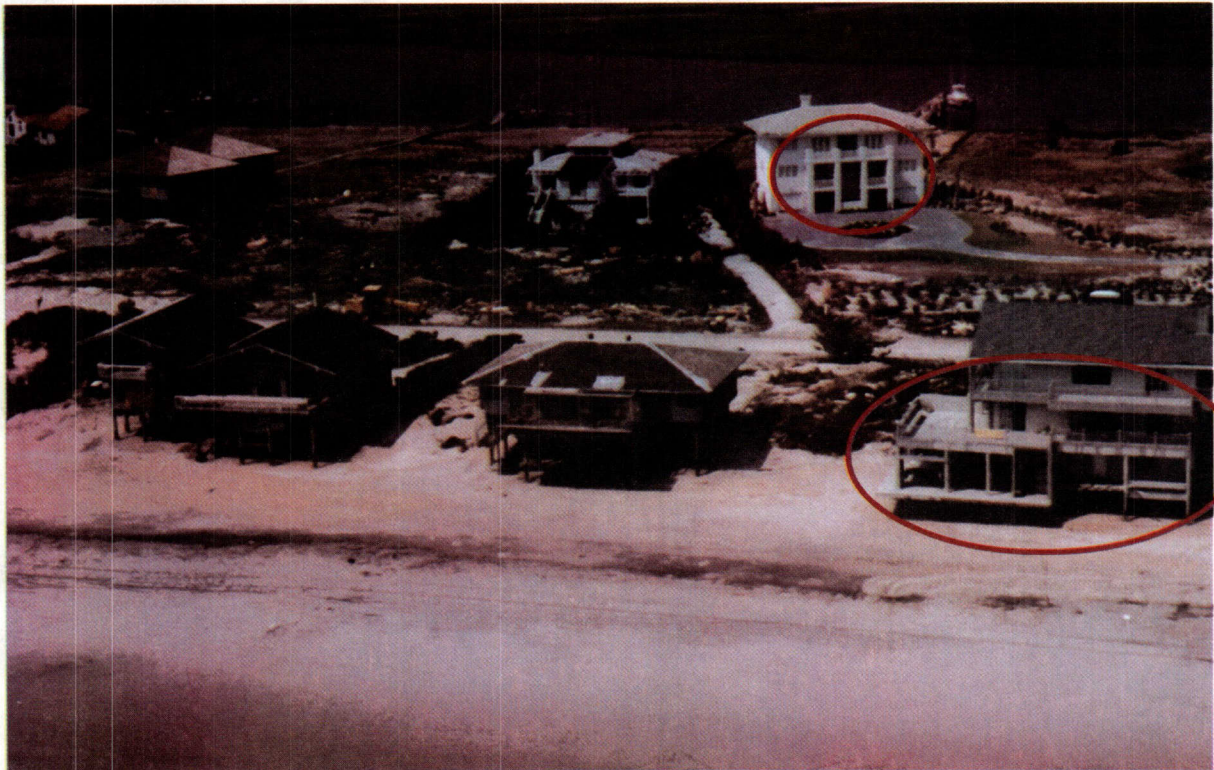
Decks, porches, and roof overhangs were often built on the seaward side of oceanfront structures and were therefore often embedded into the frontal dune (see Figure 2-9). With embedments of only 2 to 6 feet into the dune, the bottoms of the pilings or columns were often at elevations of 4 to 8 feet m.s.l. The remaining embedment depth of those deck, porch, and roof overhang supports that survived the hurricane appears to be as little as 1 to 2 feet in many cases.

*Figure 2-15 As shown by this post-Fran photograph taken at Figure Eight Island, North Carolina, a current architectural trend is the construction of multistory decks supporting roof overhangs.*

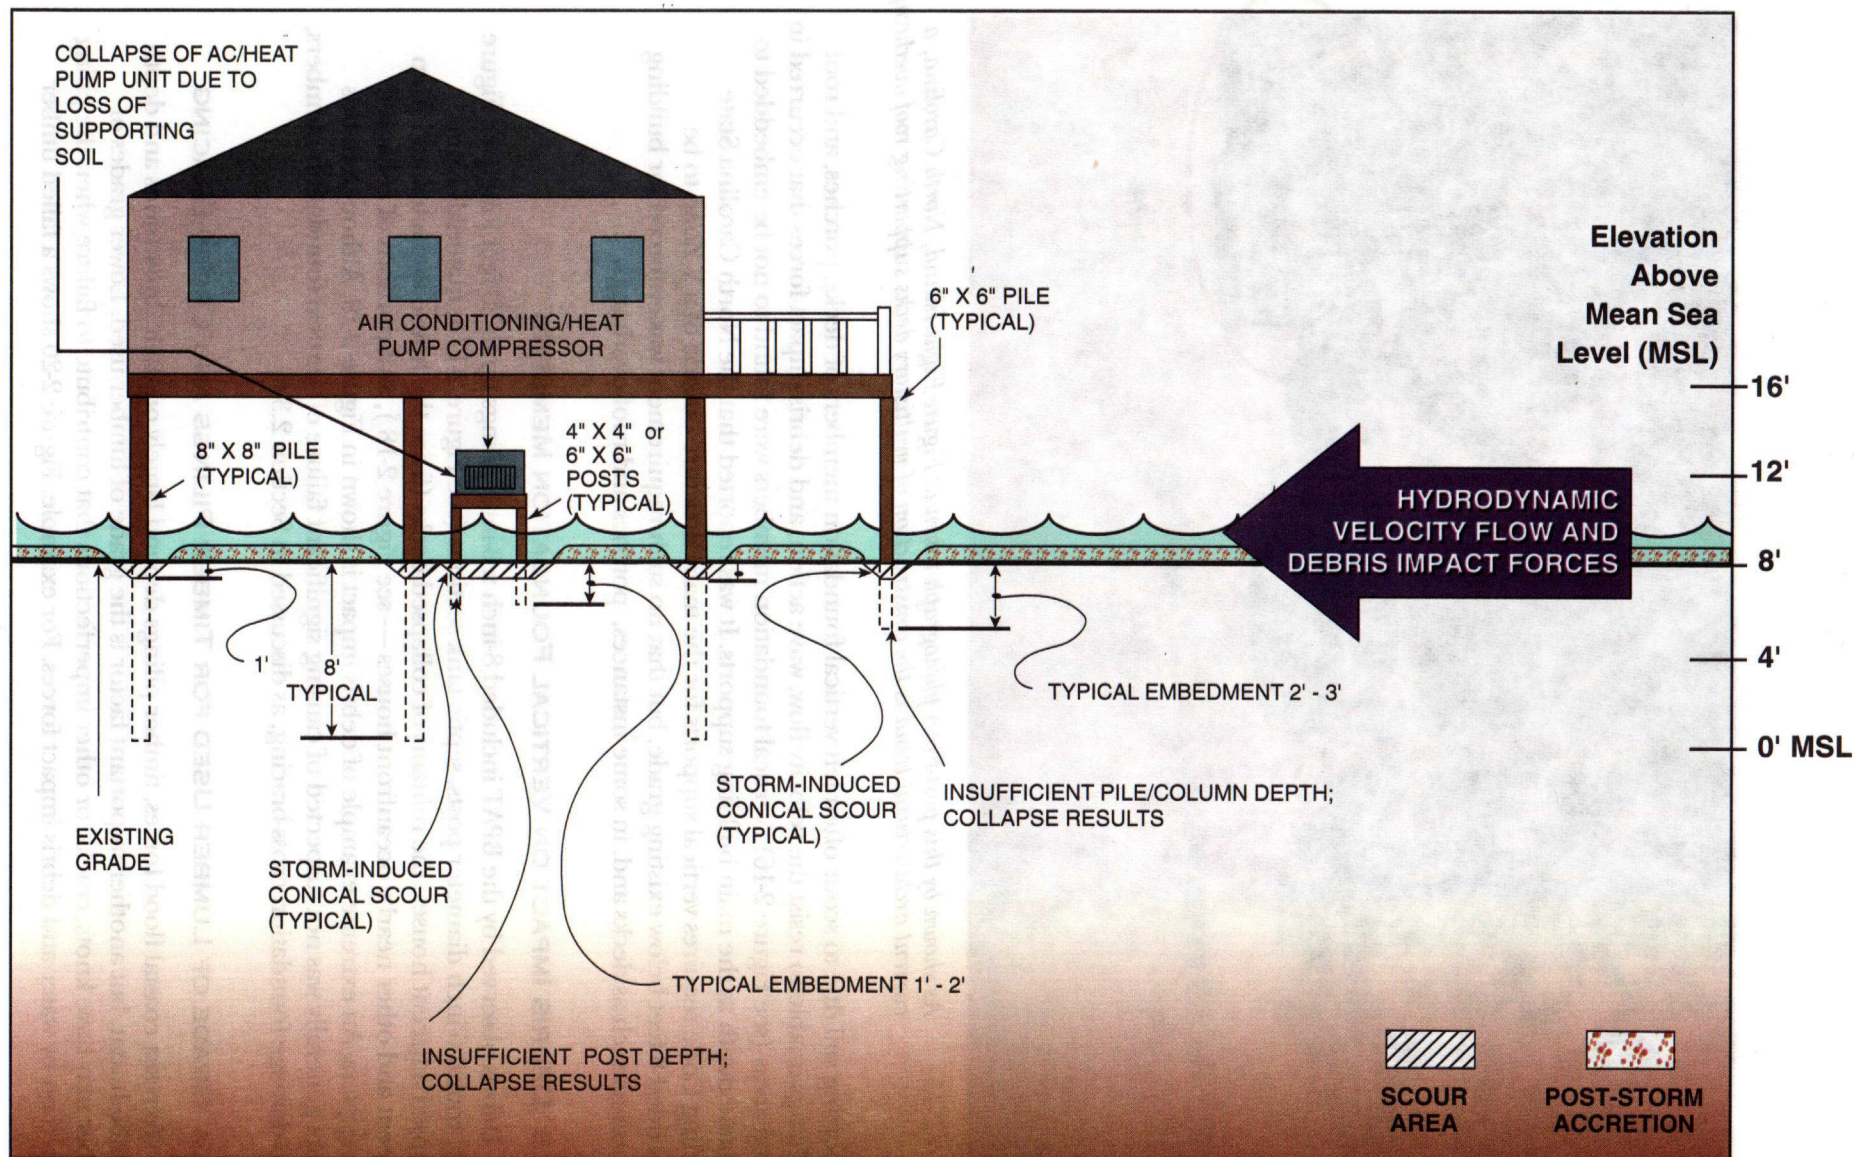
supporting soil due to scour often left vertical foundation members of decks, porches, and roof overhangs unable to resist the velocity flow, wave action, and debris impact forces that occurred in coastal areas (see Figure 2-16). Vertical foundation members were found to not be embedded to the same depth as the main building supports. It was reported that the North Carolina State Building Code requires vertical supports for the main structure outside of a V Zone to be embedded 8 feet below existing grade, but that no such requirement was enforced for building extensions such as decks and, in some instances, porches and roof overhangs.

Figure 2-16 Typical failure of deck / roof overhang and air conditioning / heat pump compressor platform for landward home.

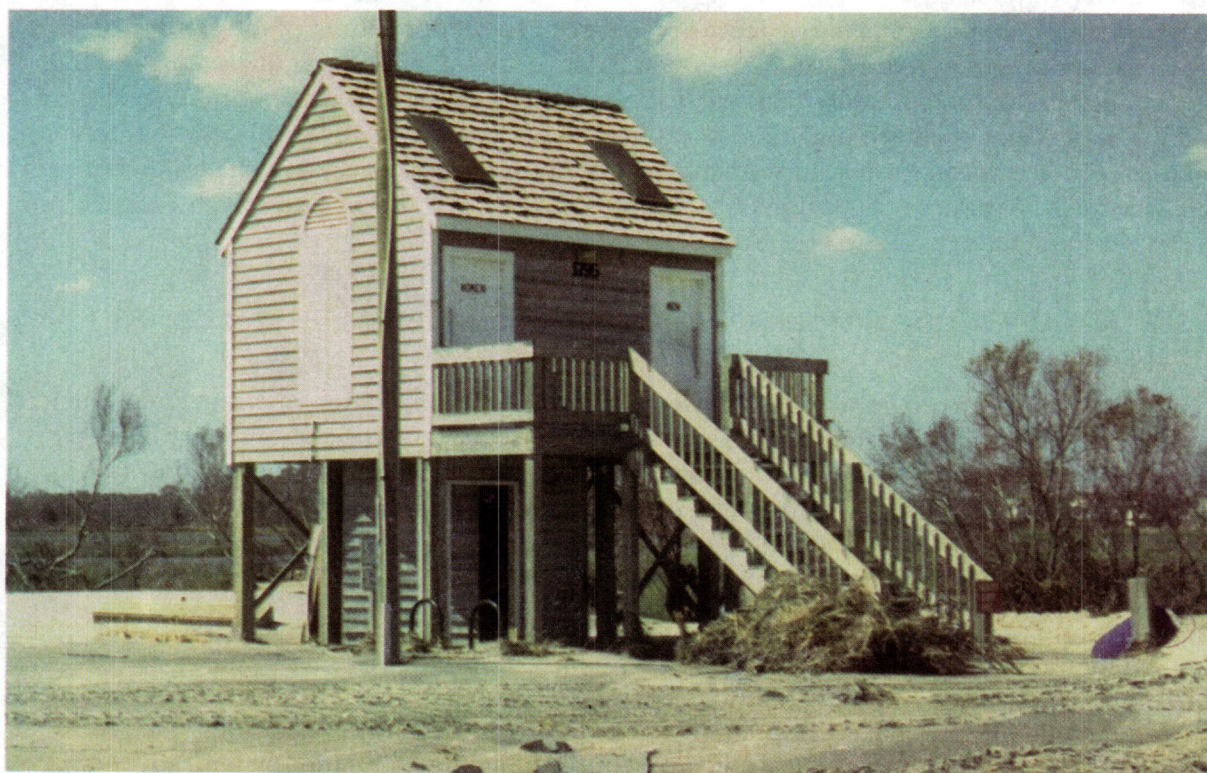
NFIP regulations require that structures in Coastal High Hazard Areas (V zones) be elevated so that the lowest horizontal structural member of the lowest floor is at or above the BFE shown on the FIRM in effect at the time of construction. In the areas visited by the BPAT, structures in V zones appeared to have been built in compliance with this requirement. For structures in A zones, the NFIP regulations require that the lowest floor be elevated to or above the BFE; no requirements are imposed for structures in B, C, and X zones. Although elevating on open foundations with lowest horizontal structural members at or above the BFE is not required outside of V zones, this practice was widely observed in A, B, C, and X zones on the barrier islands within the study area (see Figure 2-21).

Figure 2-21 *Survival of this properly elevated North Carolina State Park public rest room demonstrates the State's commitment to proper construction in coastal areas.*

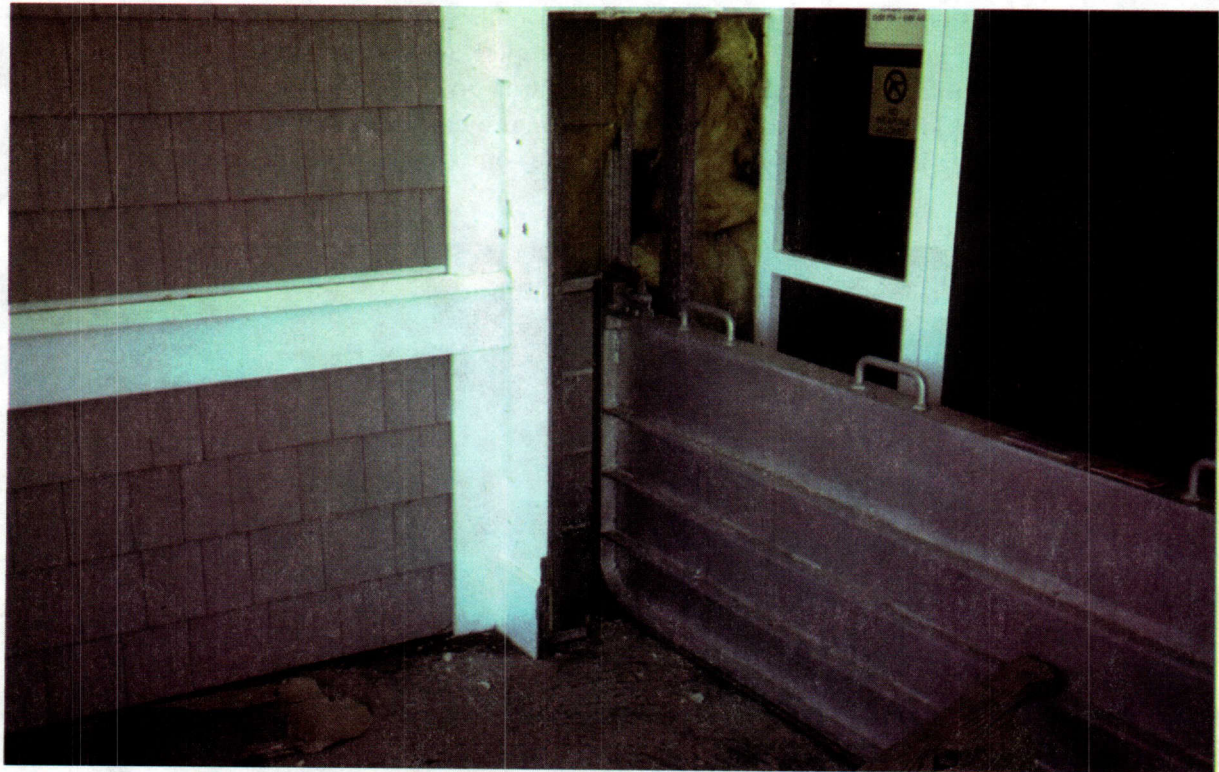
The BPAT interviewed the hotel manager and engineer during the site investigation. Both were directly involved in the renovation of the hotel. Both said that the floodproofing was worth the effort but that they wished the shields had been 1 foot higher. While the shields prevented the storm surge from entering the protected area, some water splashed over the tops of the shields. The water that passed over the top flooded the conference rooms to a depth of 4 inches. It damaged the carpeting and mildewed the wall paper. However, in the remaining portions of the hotel, which were not floodproofed, the depths of flood waters reached 18 inches. In these areas, the water damaged the sheetrock and left over 2 inches of sand on the floor. Both the manager and the engineer stated that keeping sand out of the conference area was, in itself, justification for the expense of the floodproofing.

Figure 2-40      *Engineered flood shield installed over opening to large dry floodproofed commercial building.*

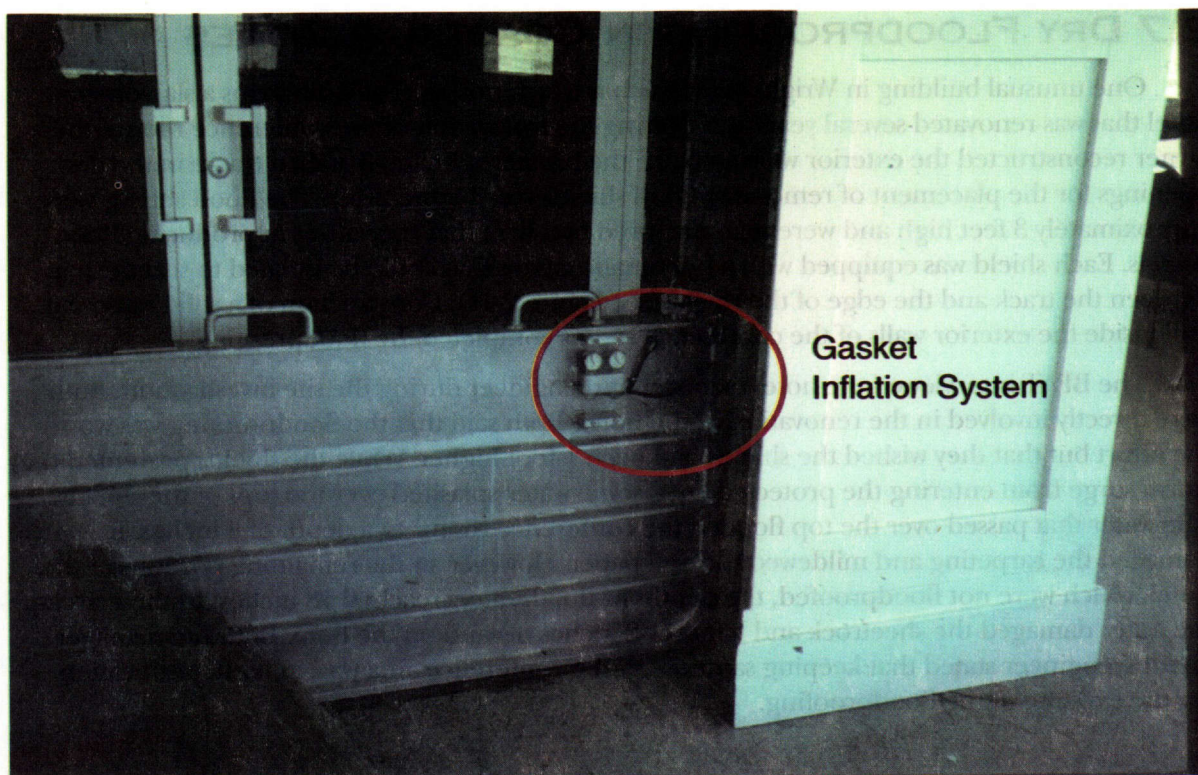
**Figure 2-41** *Buildings that are floodproofed require extensive engineering detailing. Note that this flood shield is sealed with a pneumatic gasket.*

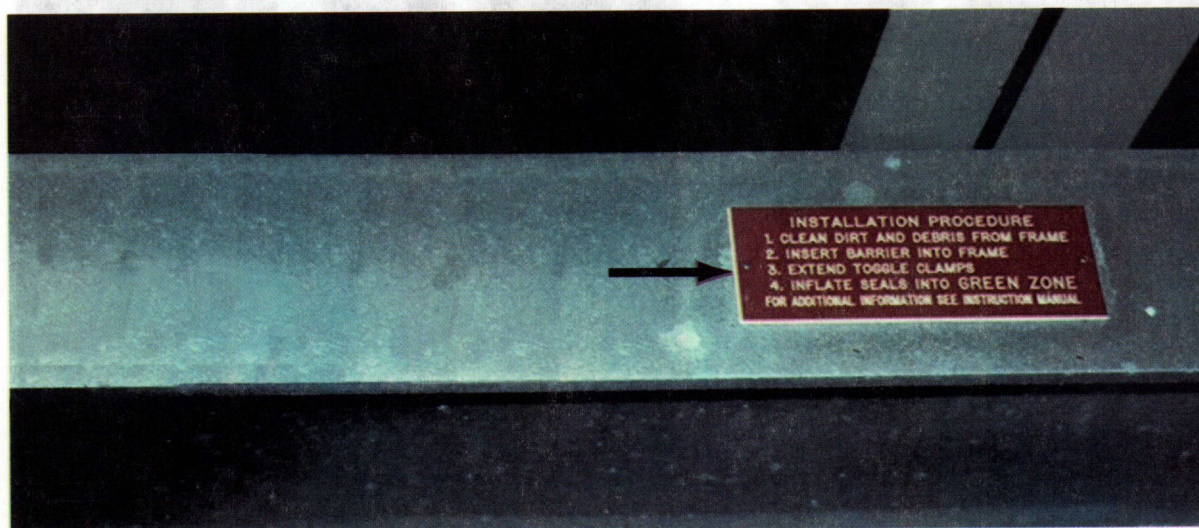
Although flood shields and other elaborate floodproofing measures can be quite effective, they often require extensive human intervention to function properly (see Figure 2-42). It should be noted that very few floodproofed buildings in coastal A zones are known to be subject to wave action. Floodproofing in areas known to be subject to wave action presents special challenges that must be addressed in the design, installation, and operation of the components of the floodproofing system.

**Figure 2-42.** *Dry floodproofing often requires extensive human intervention. Note the detailed instructions affixed to this flood shield.*

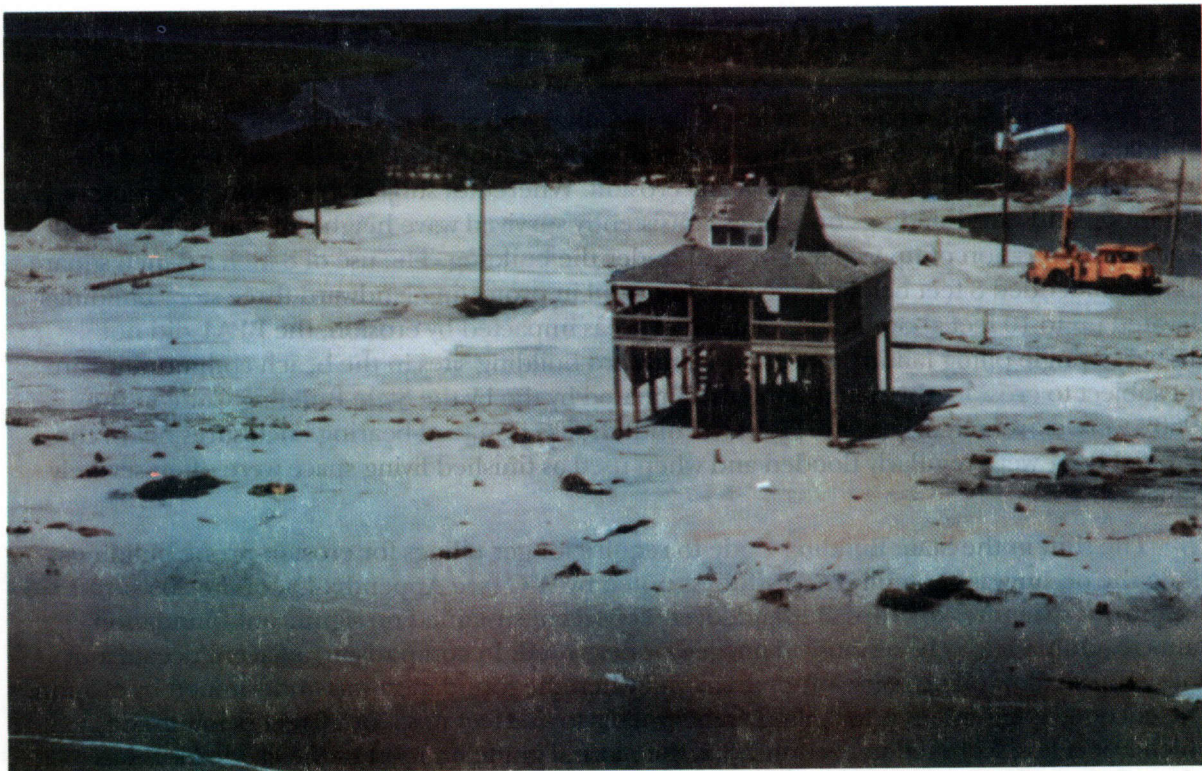
*Figure 2-46 While this house experienced 6 feet or more of vertical erosion and scour, as well as the loss of breakaway wall panels, the foundation and superstructure performed as designed.*

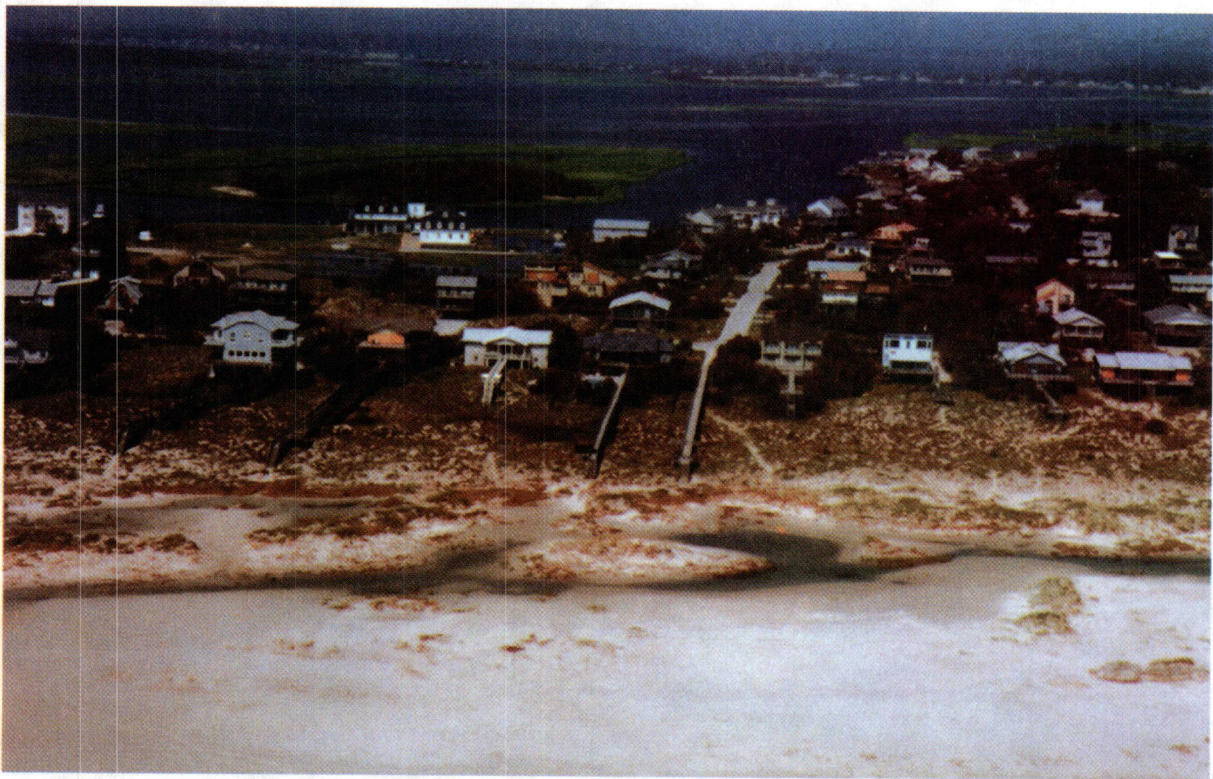
*Figure 2-47 As shown by this post-Fran photograph taken at Emerald Isle, North Carolina, proper elevation and setback from the oceanfront in conjunction with substantial protection afforded by dunes resulted in little or no flood damage to the oceanfront row of buildings.*

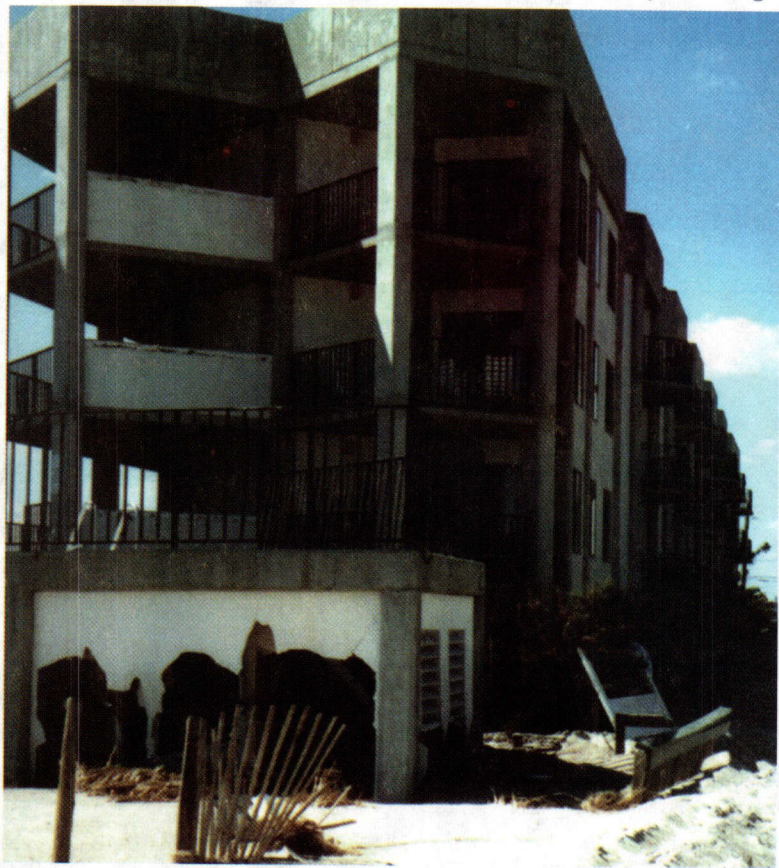
*Figure 2-48 This large, engineered oceanfront structure performed as designed.*

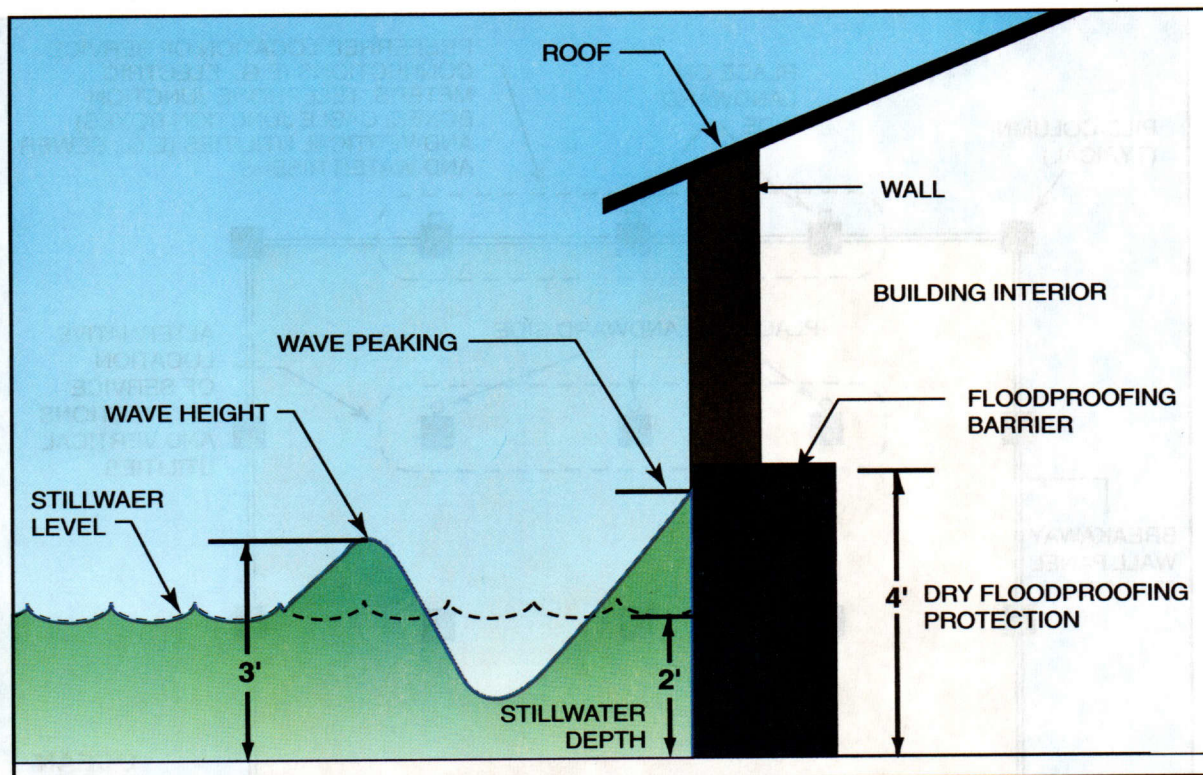
Figure 3-8 Dry floodproofing in coastal A zones.

Studies performed by the U.S. Army Corps of Engineers (COE) National Flood Proofing Committee, found in the COE publication *Floodproofing Tests*, 1988, indicate that dry floodproofing can be used in areas that experience flooding to a depth of 3 feet. The COE did not study coastal effects, including wave action. Wave action, especially waves breaking on the vertical dry floodproofing components, will add significant loads to the floodproofing system.

Therefore, it is recommended that dry floodproofing be used in coastal floodplains only where the stillwater depth is no more than 2 feet above grade during the base flood. Where the stillwater depth is 2 feet, the wave crest elevation will be approximately 1 foot above the stillwater elevation, and wave breaking and overtopping will reach even higher. To protect a building from wave overtopping where the stillwater depth is 2 feet, 4 feet of dry floodproofing is recommended (see Figure 3-8). In no case should the increase in floodproofing height be used to compensate for higher stillwater depths without a detailed engineering analysis.

Dry floodproofing is normally designed for velocity flows that do not exceed 10 feet per second. Velocities up to 10 feet per second can be converted to an approximate equivalent hydrostatic head (see FEMA 259: *Engineering Principles and Practices for Retrofitting Flood Prone Residential Buildings*). In the case of structure subjected to a 2-foot stillwater flood depth, a velocity of 10 feet per second can be converted to an approximate increase of 1 foot of flood depth. This provides further justification for restricting floodproofing to coastal structures that are subject to no more than 2 feet of stillwater flooding. For additional information on proper floodproofing design and construction criteria, see FEMA 259, *Engineering Principles and Practices for Retrofitting Flood-Prone Residential Structures*, and FEMA's Technical Bulletin No. 3, *Non-Residential Floodproofing — Requirements and Certification*.
